Manhole Inspection Summary

Manhole # S31EE1018MH

Insp Date: **5/18/07 9:56 AM**

Location Address: **110 UNIVERSITY PKWY**

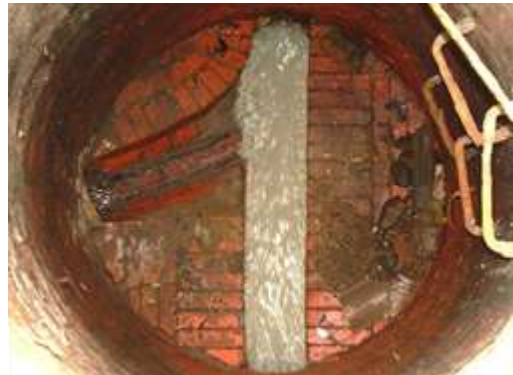
Top View

Corroded steps. Evidence of surcharge - Bench debris.

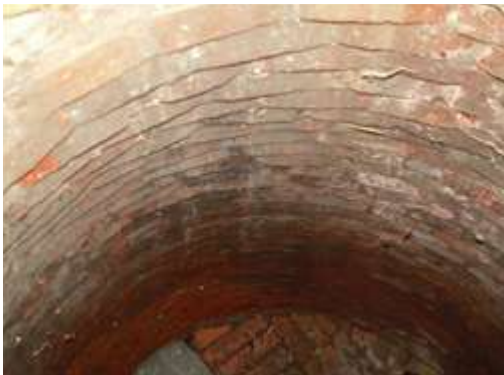
Defect

Condition: ☐ Sound ☐ Cracked ☐ Root Intrusion ☐ Loose Brick ☒ **Deteriorated**

Infiltration: ☐ None ☒ **Joint** ☐ Cracks ☒ **Mortar** ☐ Roots ☐ Wall

Infiltration: ☐ None ☐ Joint ☐ Cracks ☐ Mortar ☐ Roots ☒ **Wall**

Adjustment and Barrel infiltration.

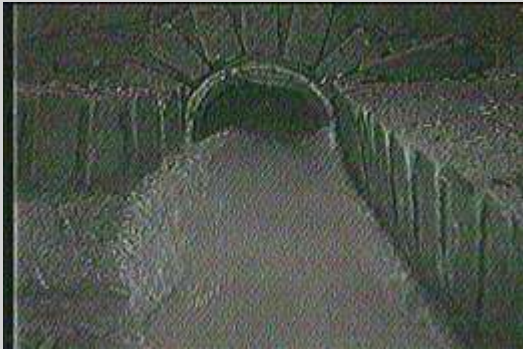
8 in. Circular Gravity Sewer Pipe Out @ 12 O'Clock

Infiltration: **None** Pipe Seal Cond: **Cracked**

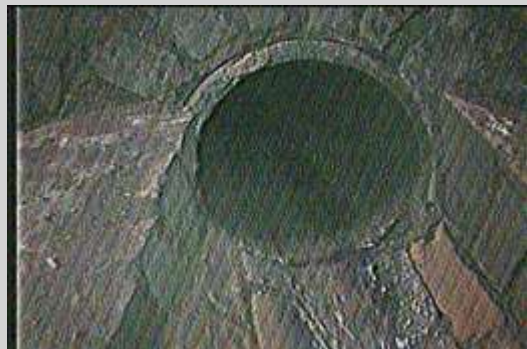
Pipe In @ 9 O'Clock

Pipe Seal Cond: **Cracked**
